# Inspection Report

**Property Address:**  
Sample Address

**Inspection performed by:**  
**Arch Inspections LLC**  
**PO Box 1779**  
**Newark, NJ 07101**

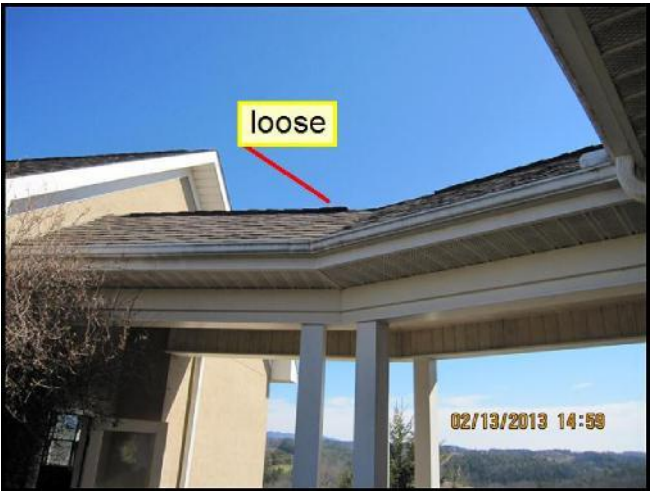
1.2 Picture 1

Ridge vent loose at end above breezeway and needs to be fastened. Nail head used to fasten should be sealed with sealant.

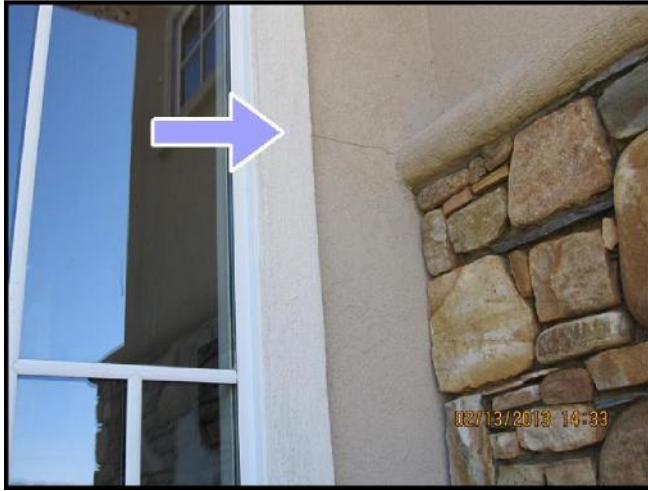
2.0 Picture 1

- (1) Some hairline cracks in areas around home. These appear to be typical.

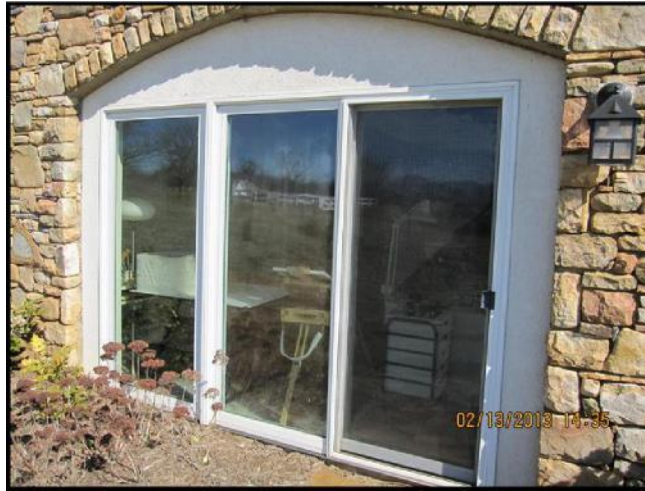
2.1 Picture 1

Glass panel doors/window at right side (facing front) cloudy or seal is broken. Glass panes that have lost their seal (cloudy) can usually be replaced without replacing the entire unit. A qualified contractor should inspect and repair as needed.

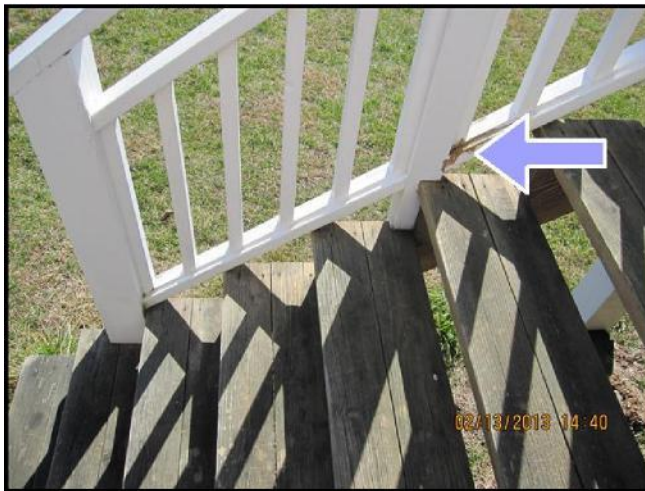
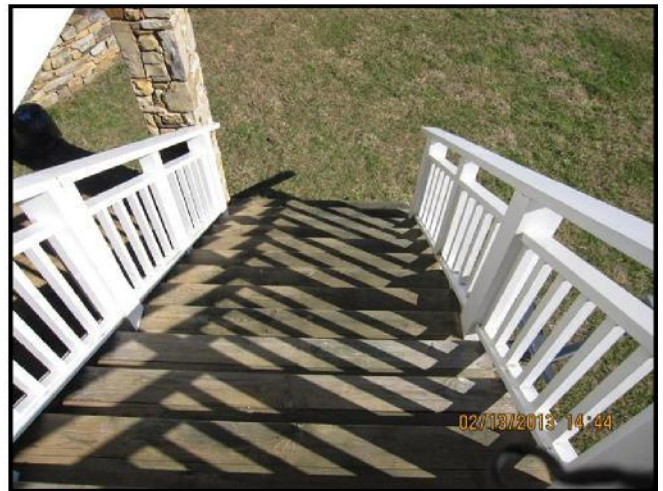
2.3 Picture 1

Bottom rail is soft or deteriorated in one area and other areas weathered. Needs prep and paint. Deck stairs need algae removed with a cleaner and seal with a non skid weather sealant.

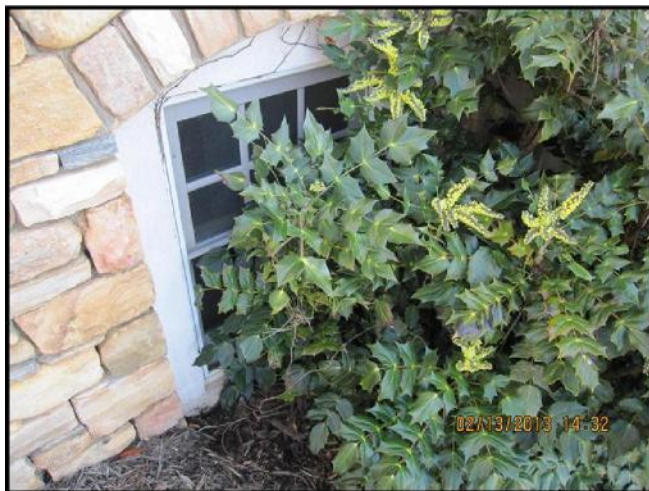
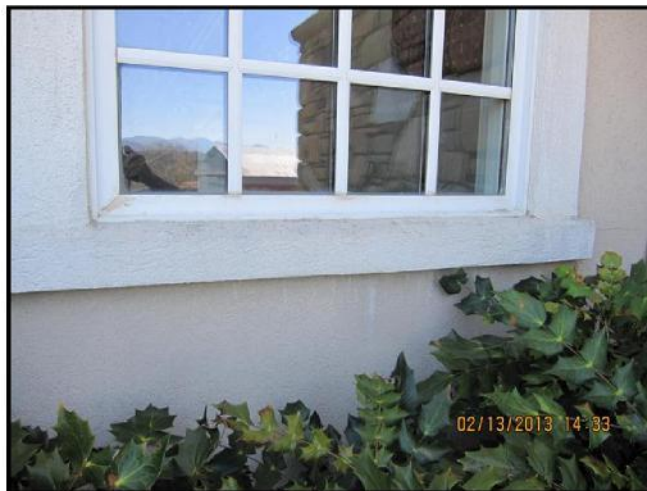
2.4 Picture 2

Thorny bushes or vegetation obstructing access and should be relocated to allow clearance from siding of home

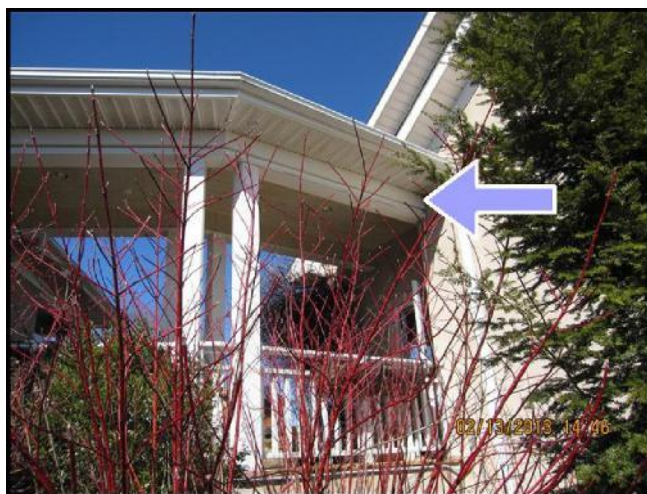
2.5 Picture 1

Some areas need prep and paint along breezeway at top fascia trim (cosmetic).

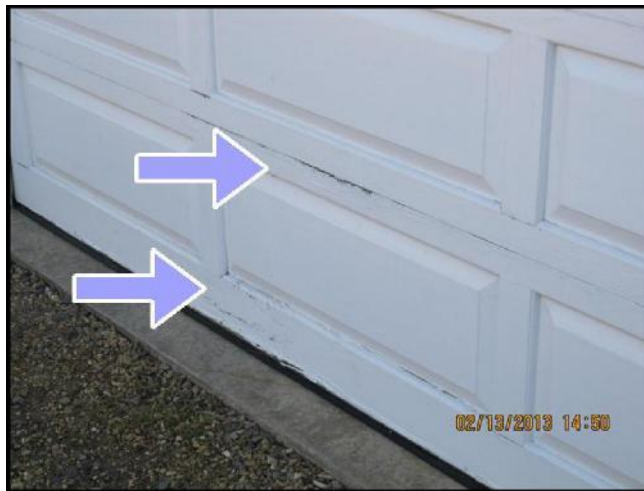
3.3 Picture 1

Weathered needs prep and paint at Garage door.

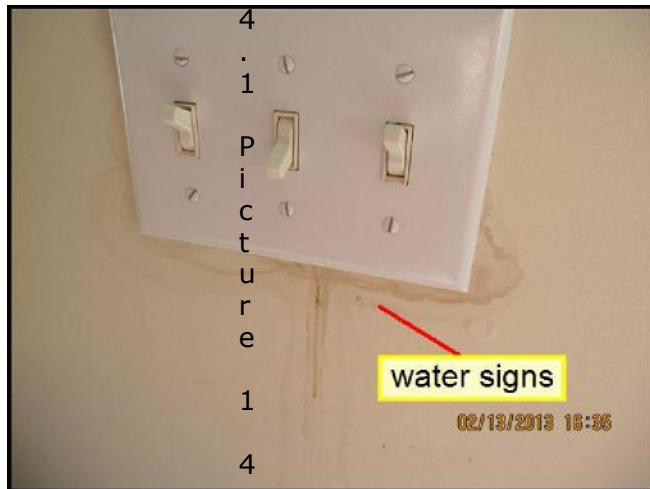
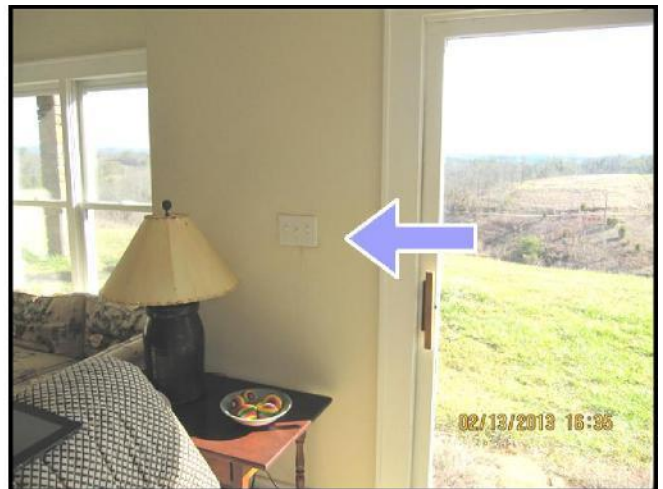
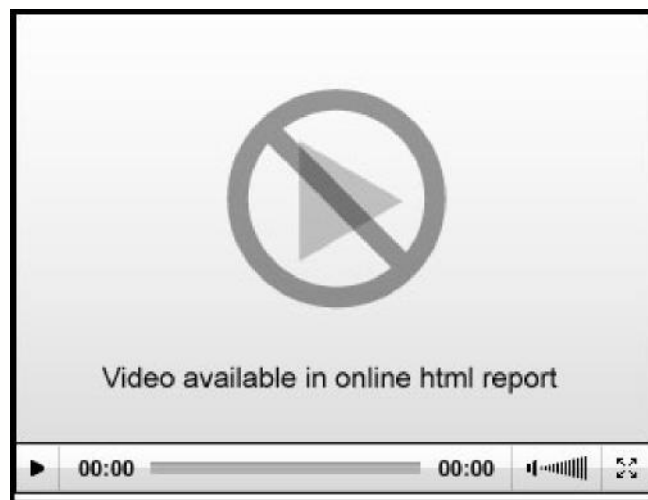
1 Picture 2 wall switch Lower level

Wall switch at lower level shows evidence of water getting in from outside? There is a light fixture in relation to this wall switch and perhaps water is getting in there? i recommend further investigation to determine location and correct.

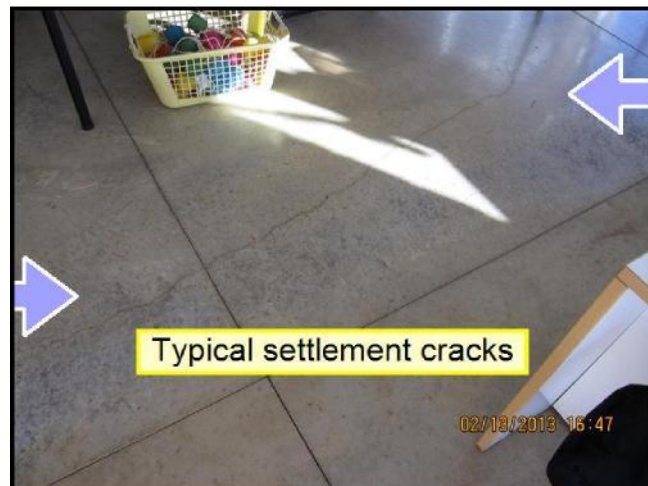
4.2 Picture 1

Lower level concrete has typical settlement cracks. We did not remove area rug or inspect underneath it.

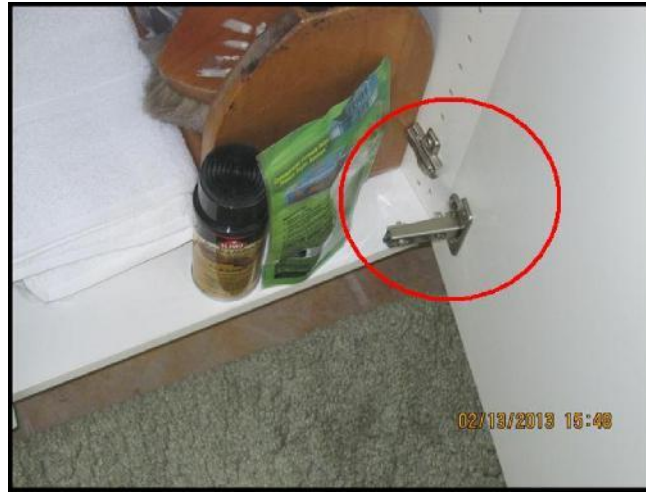
4.4 Picture 1

Hinge needs repair/replace at sink base in master bath.

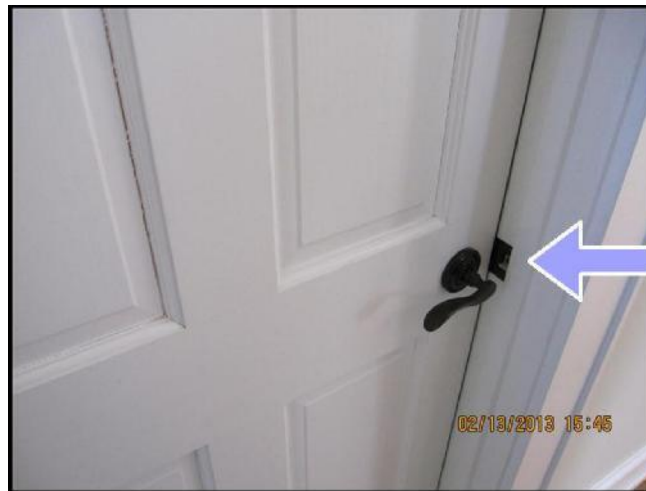
4.5 Picture 1

Master bedroom closet door (His) will not latch easily, needs adjustment

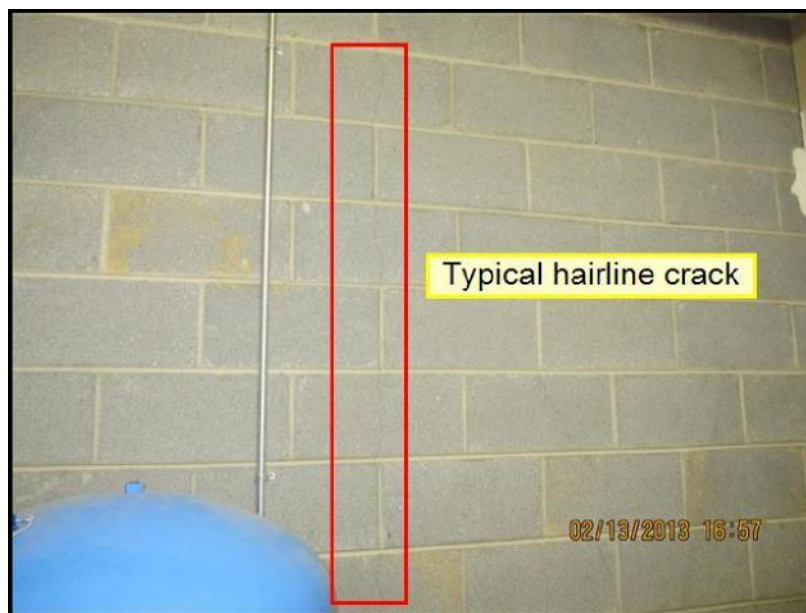
5.1 Picture 1

Hairline cracks in wall (typical).

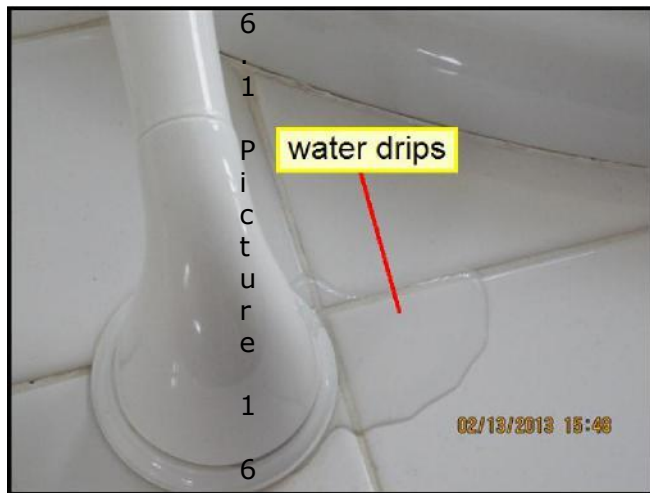
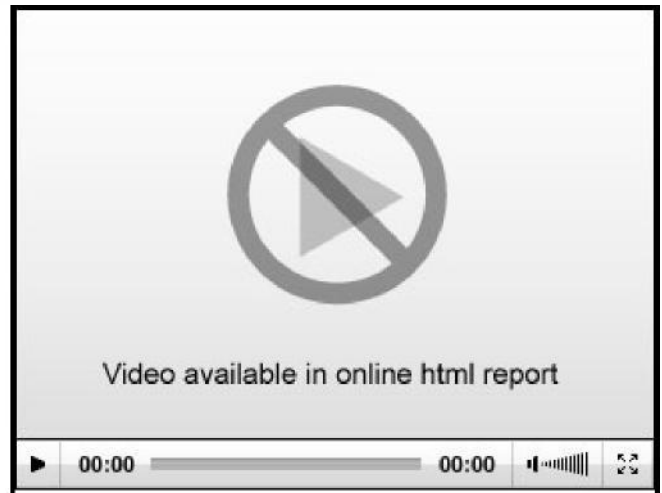
1 Picture 2

(1) Water drips from control knob on Jacuzzi brand tub. Also the lever to switch from spout to shower head works but feels weak when moved/turned and I am not sure if it is standard or loose? Recommend a plumber to inspect and repair as needed.

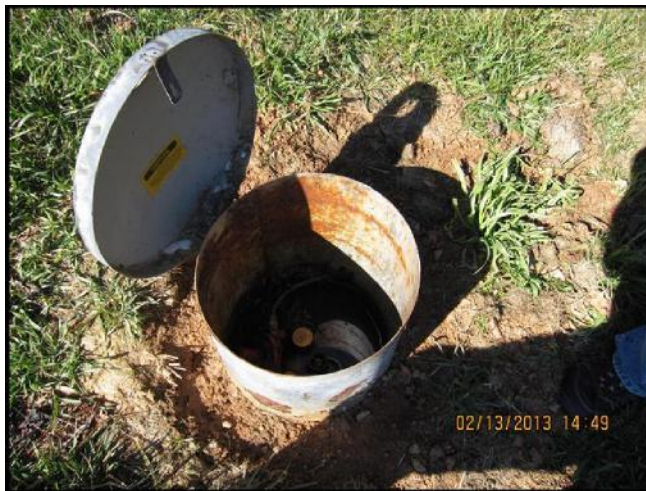
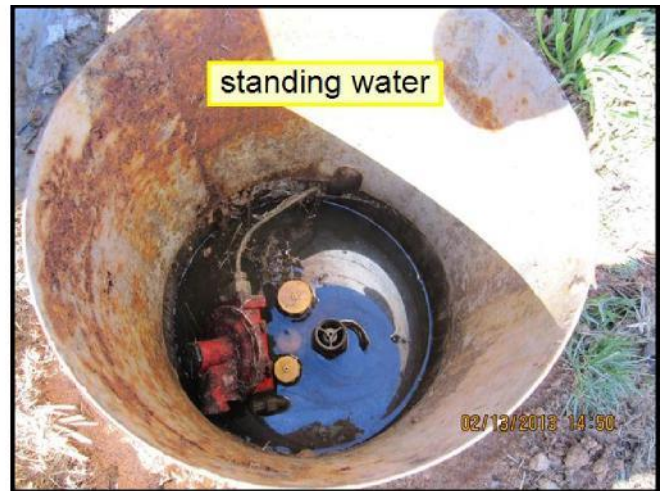
6.4 Picture 2 propane tank valves

(1) Standing water should be removed and prevented from occurring at propane valves and meter access.

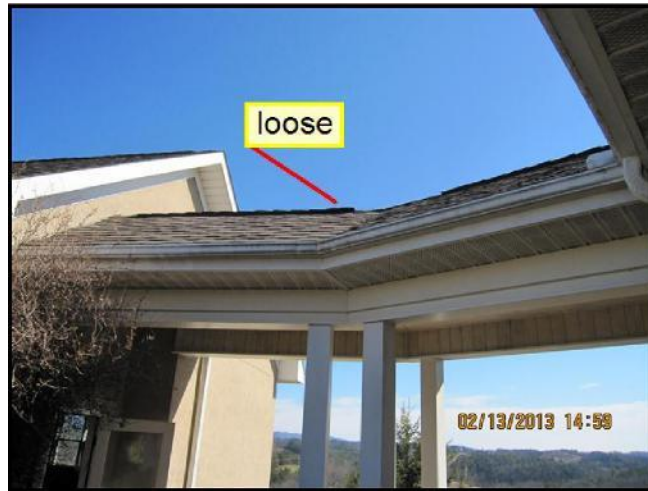
1.2 1

Ridge vent loose at end above breezeway and needs to be fastened. Nail head used to fasten should be sealed with sealant.

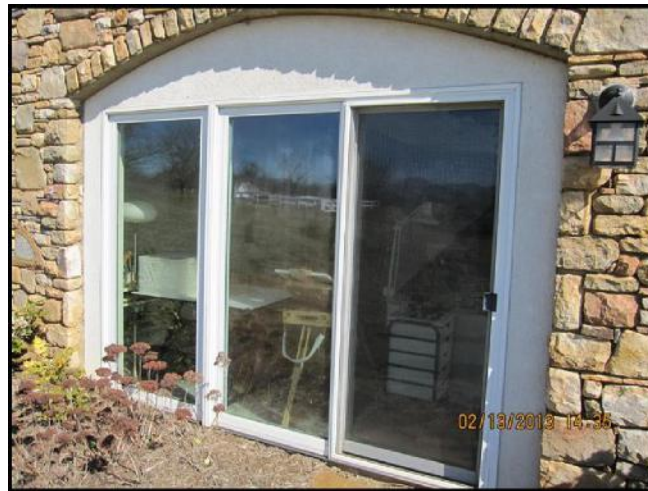
2.1 1

Glass panel doors/window at right side (facing front) cloudy or seal is broken. Glass panes that have lost their seal (cloudy) can usually be replaced without replacing the entire unit. A qualified contractor should inspect and repair as needed.

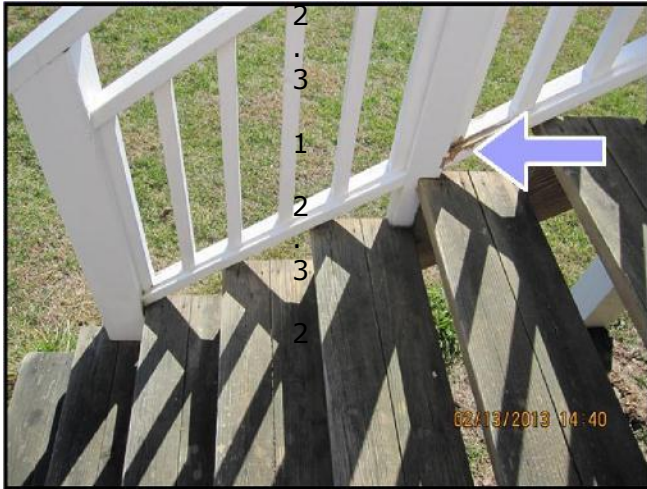
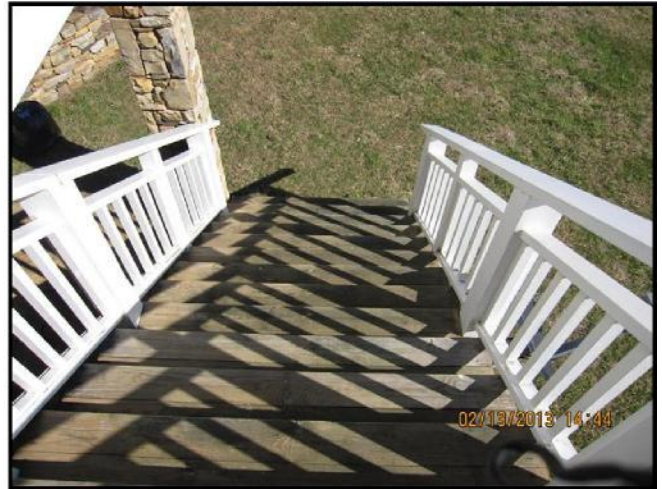
Bottom rail is soft or deteriorated in one area and other areas weathered. Needs prep and paint. Deck stairs need algae removed with a cleaner and seal with a non skid weather sealant.

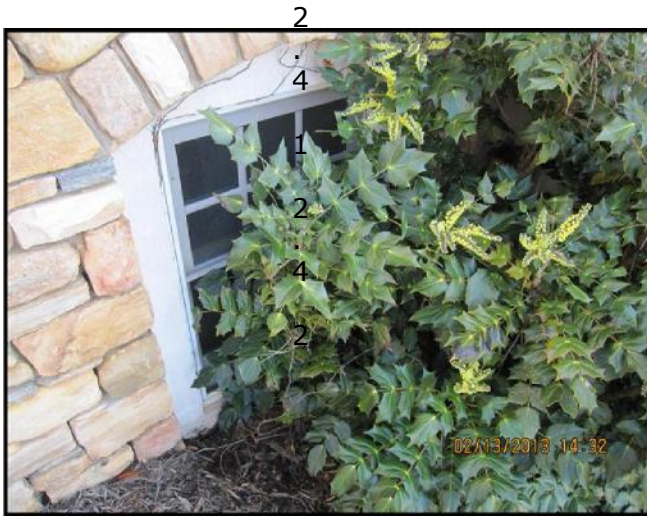
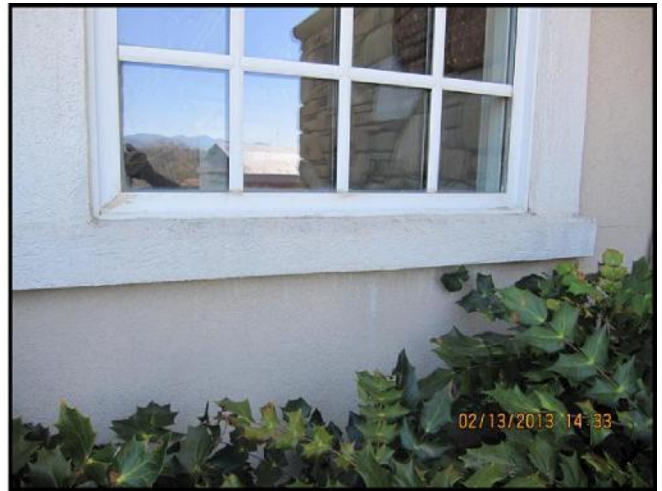
Thorny bushes or vegetation obstructing access and should be relocated to allow clearance from siding of home

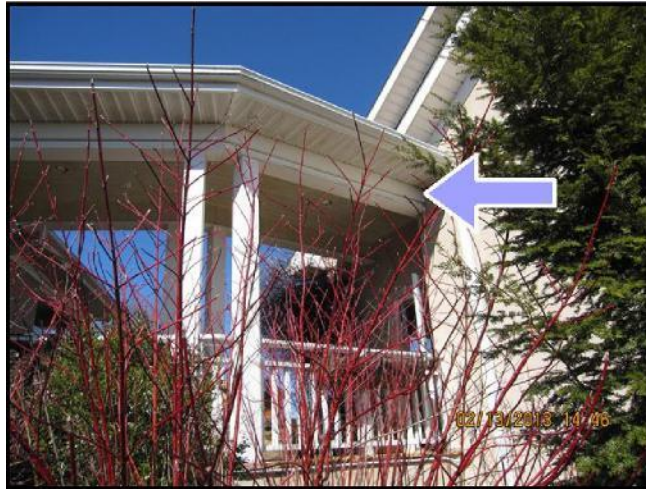
2.5 1

Some areas need prep and paint along breezeway at top fascia trim (cosmetic).

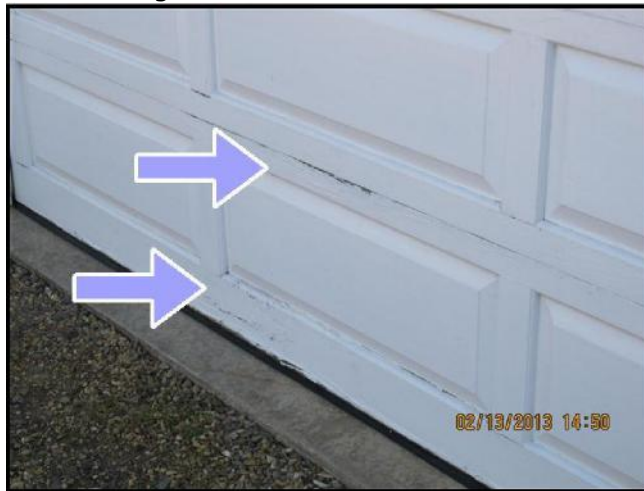
3.3 1

Weathered needs prep and paint at Garage door.

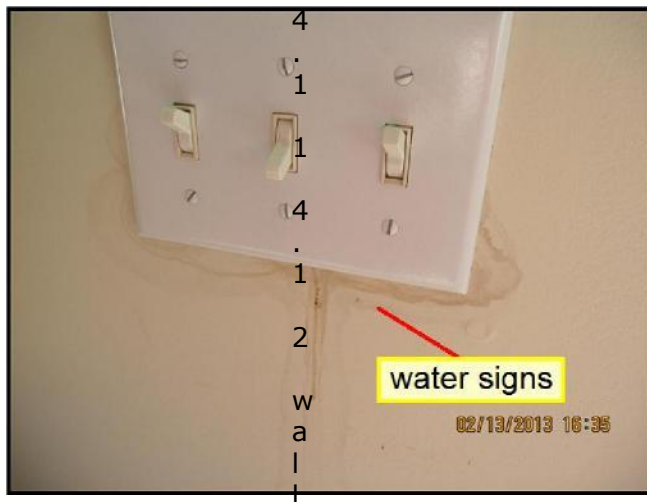
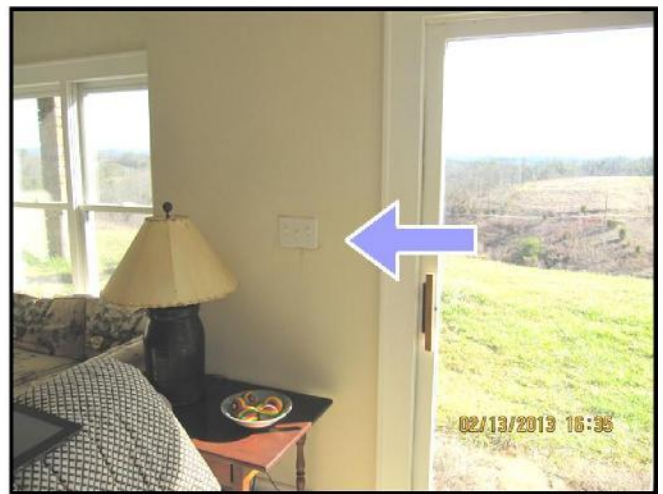
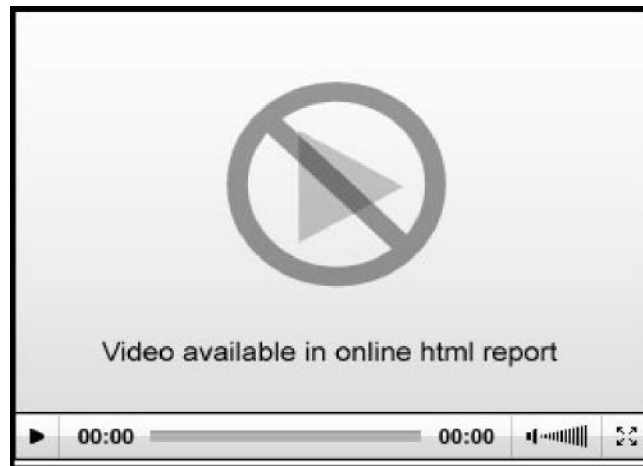
4.1 3

Wall switch at lower level shows evidence of water getting in from outside? There is a light fixture in relation to this wall switch and perhaps water is getting in there? i recommend further investigation to determine location and correct.

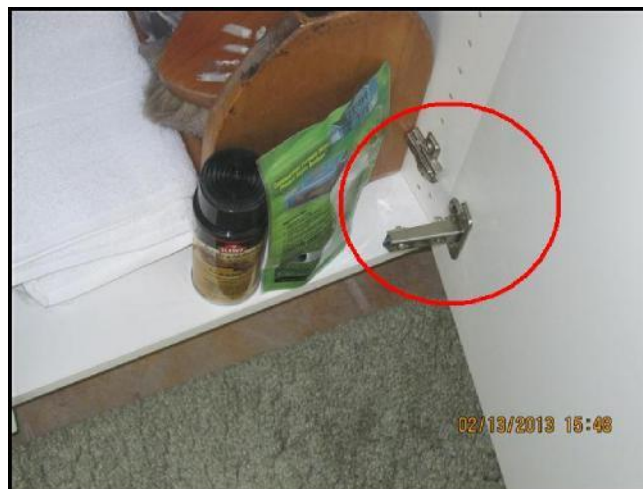
4.4 1

Hinge needs repair/replace at sink base in master bath.

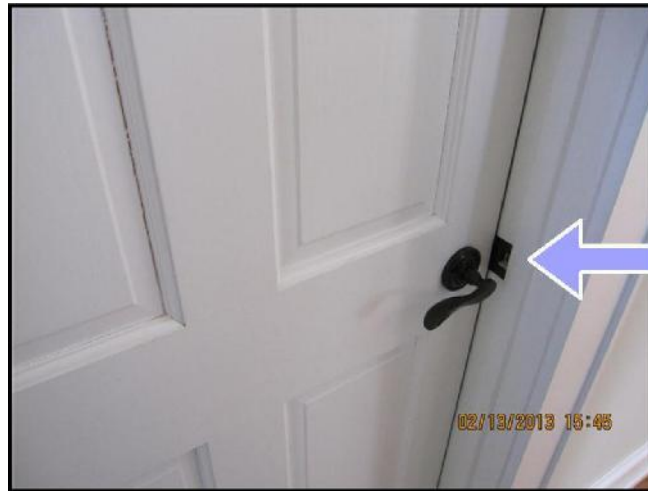
4.5 1

Master bedroom closet door (His) will not latch easily, needs adjustment

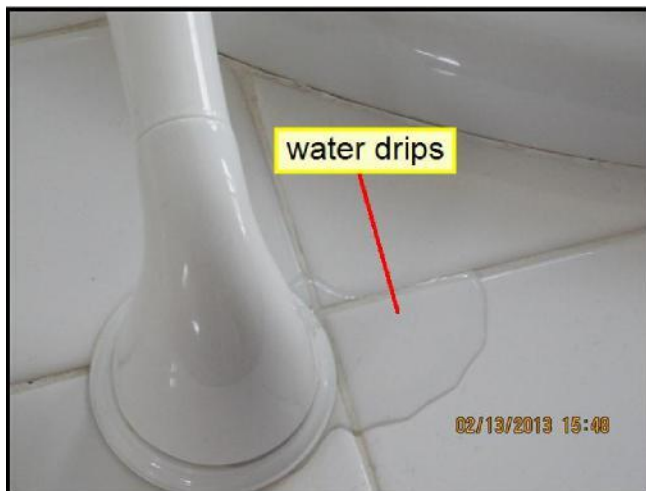
6.1 1

(1) Water drips from control knob on Jacuzzi brand tub. Also the lever to switch from spout to shower head works but feels weak when moved/turned and I am not sure if it is standard or loose? Recommend a plumber to inspect and repair as needed.

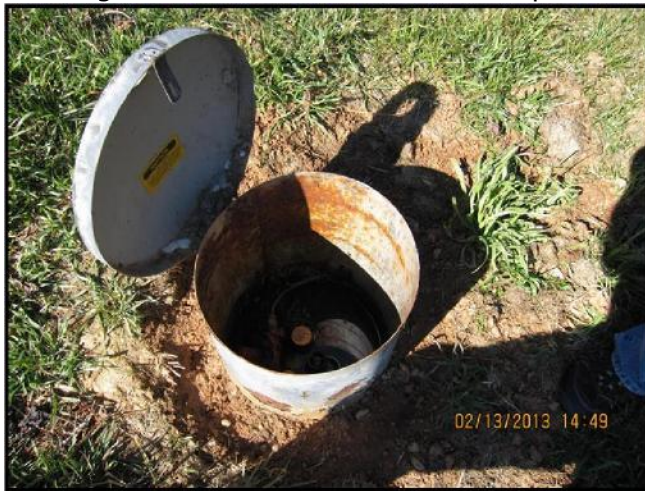
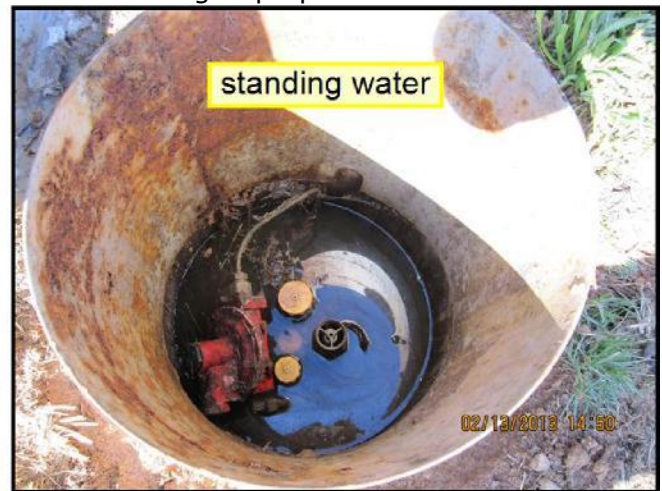
6.4 1

(1) Standing water should be removed and prevented from occurring at propane valves and meter access.
