Sample Commercial Inspection Report

Property Address:
Arch

Arch Inspections LLC

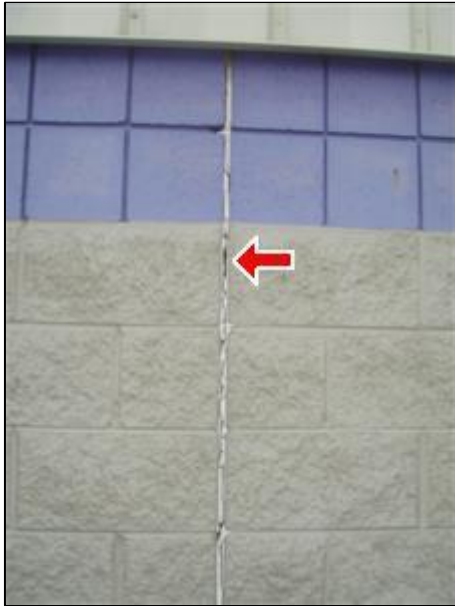
2.0 Picture 1

The exterior control joints need to be caulked to prevent water from entering the block walls.(Picture 1)

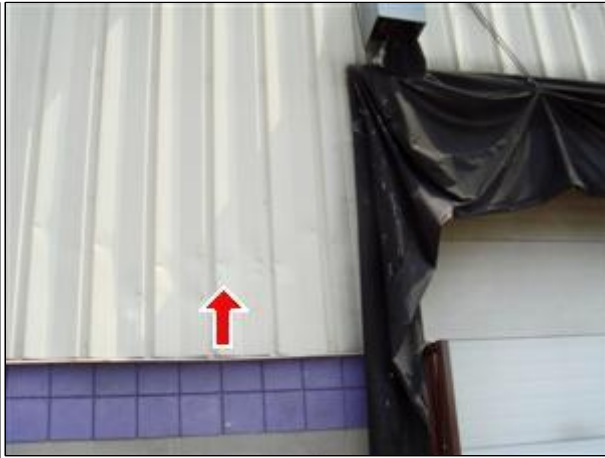
2.0 Picture 2

The siding at the back of the building is dented from the trucks being to close to the building.(Picture 2)

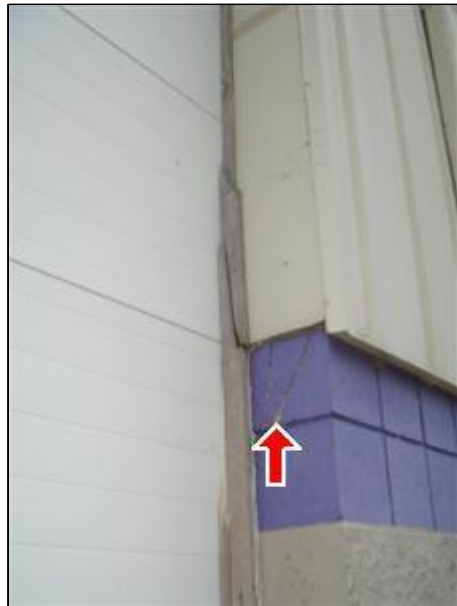
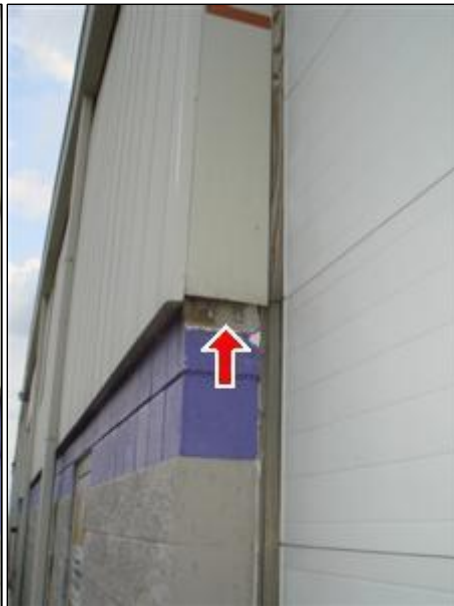
2.0 Picture 3

The blocks at the north side is braking away from the steel anchors in the block and the steel expanding.(Picture 3)
(Picture 4)

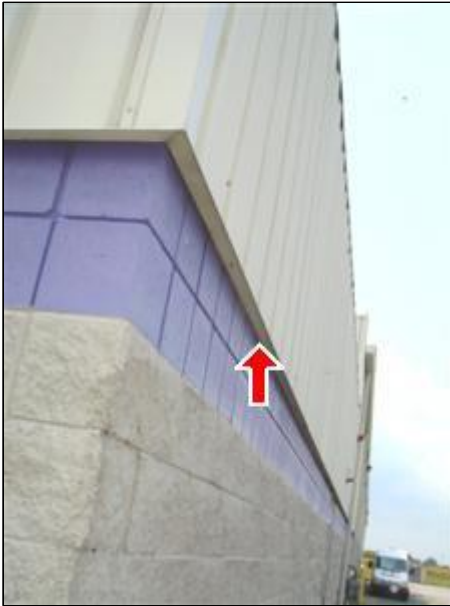
2.0 Picture 5

There is a large BEE'S nest behind the siding at the north east corner near the employees entry.(Picture 5)

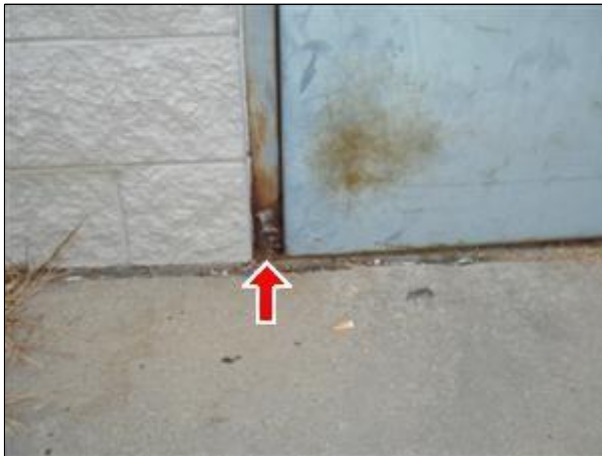
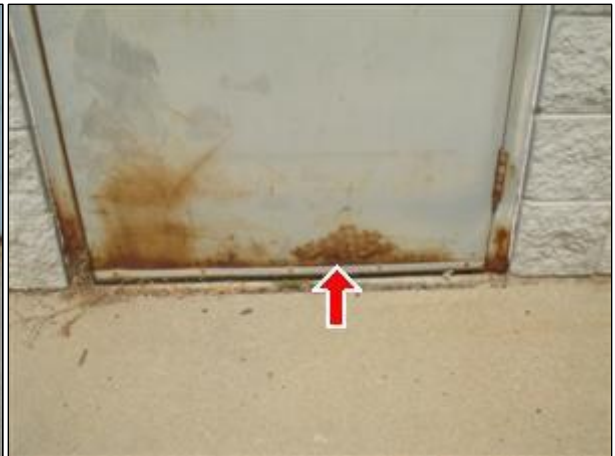
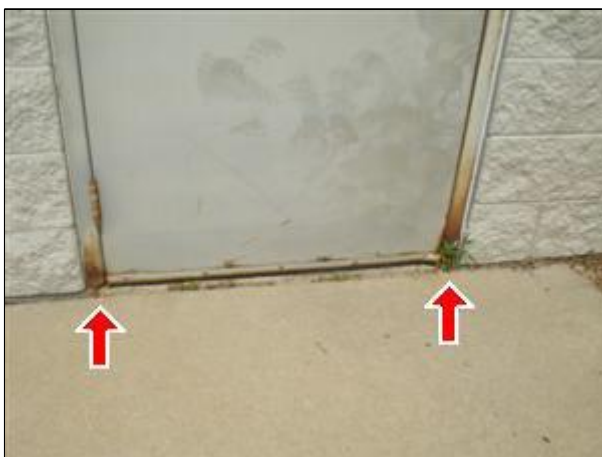
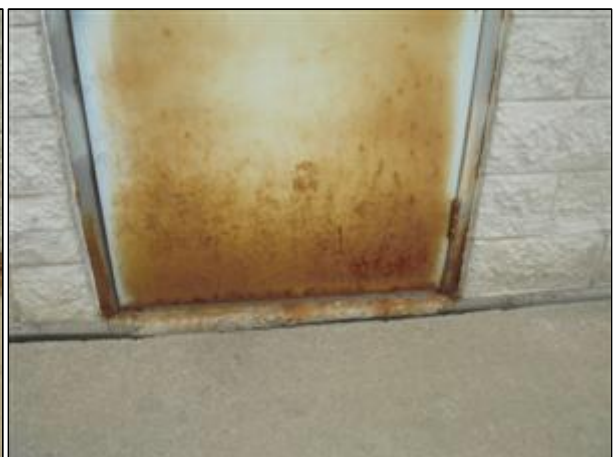
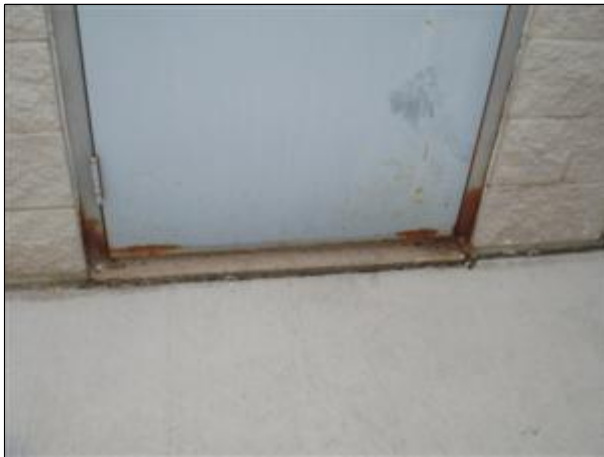
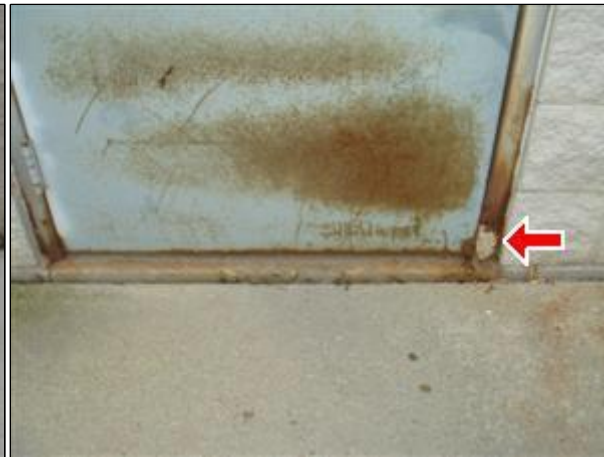
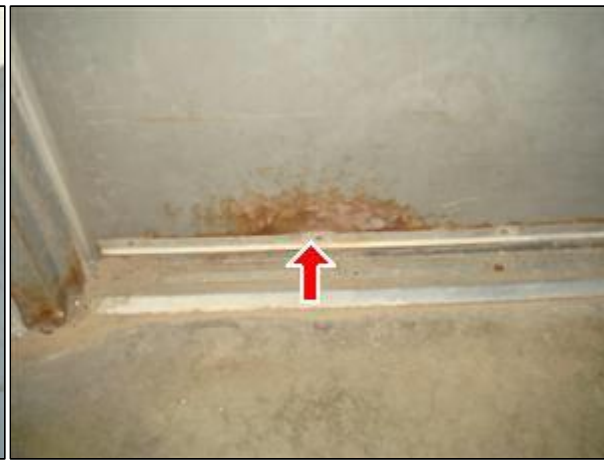
All of the exterior metal doors and frames on the north and south side of the building are rusting away. The doors on the south side are rusted thru. (Picture 1)(Picture 2)(Picture 3)(Picture 4)(Picture 5)(Picture 6) (Picture 8)

All of the exterior metal doors and frames on the north and south side of the building are rusting away. The doors on the south side are rusted through.(Picture 1)(Picture 2)(Picture 3)(Picture 4)(Picture 5)(Picture 6) (Picture 8)

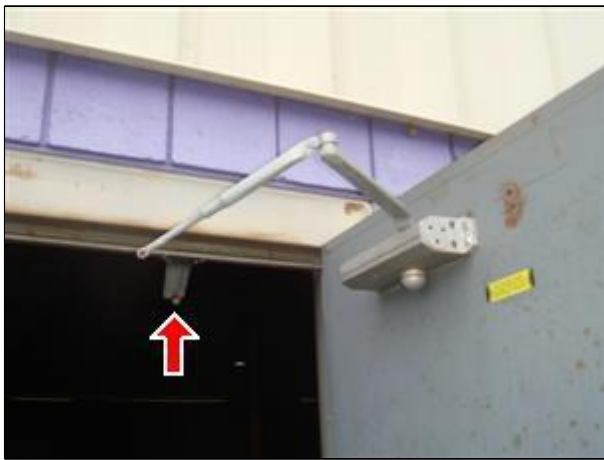
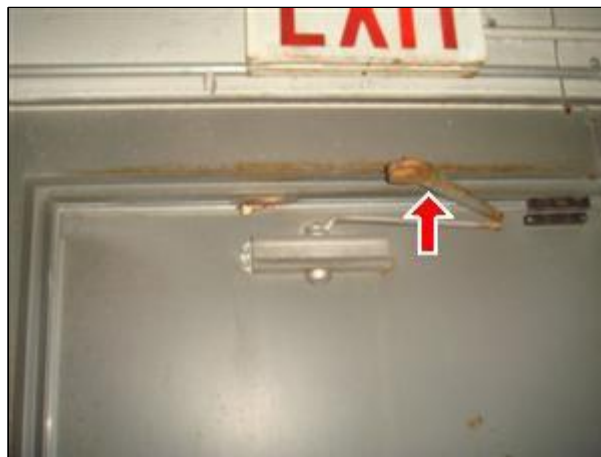
Two of the door closer on the south side doors are pulled loose. (Picture 7)(Picture 9)

Two of the door closers on the south side doors are pulled loose.(Picture 7)(Picture 9)

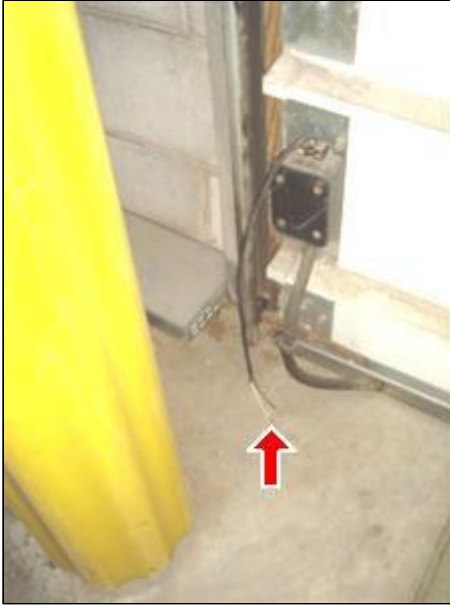
2.3 Picture 1

Overhead door #1 is the only door that has a working auto safety reversing bottom switch.(Picture 1)

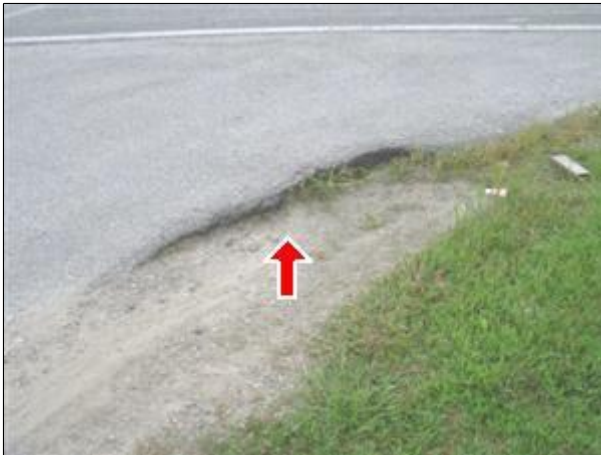
2.5 Picture 1

The driveways and parking lots are not being maintained.

The edge of the driveways at the road have large holes in the gravel shoulders.(Picture 1)

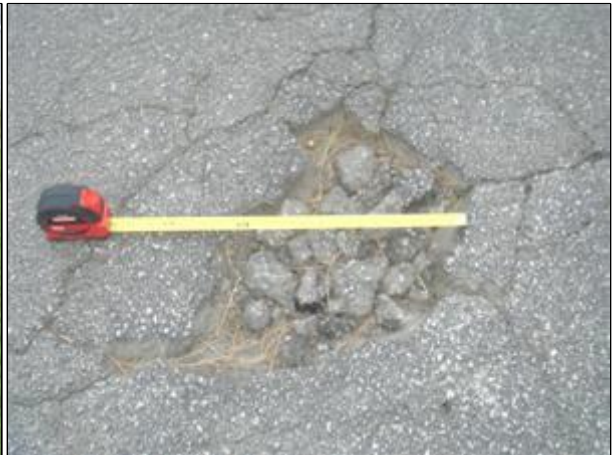
2.5 Picture 2

There is a 12" hole in the asphalt in the driveway at the customer parking area.(Picture 2)

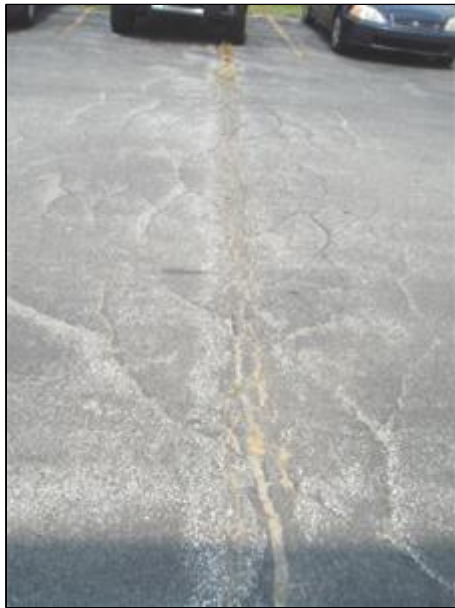
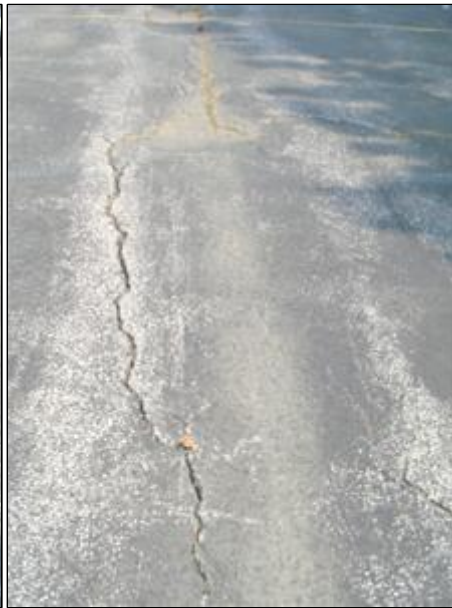
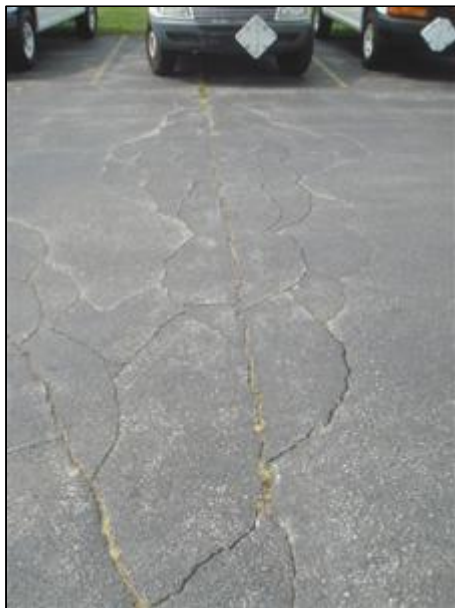
There is several seams that have not been sealed , allowing water to enter the subbase causing the asphalt on each side of the joint to breakup..(Picture 3) south side(Picture 4) north side(Picture 5)

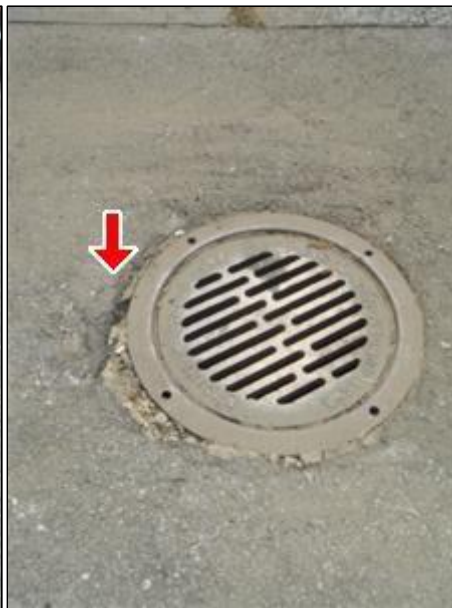
2.5 Picture 6

The asphalt around the south side catch basin is settling away from the drain.(Picture 6)

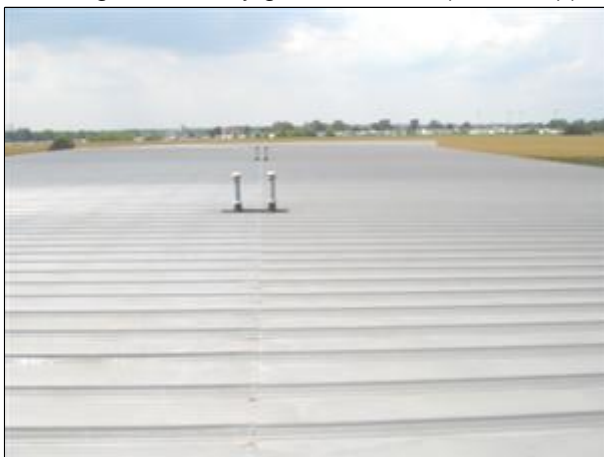
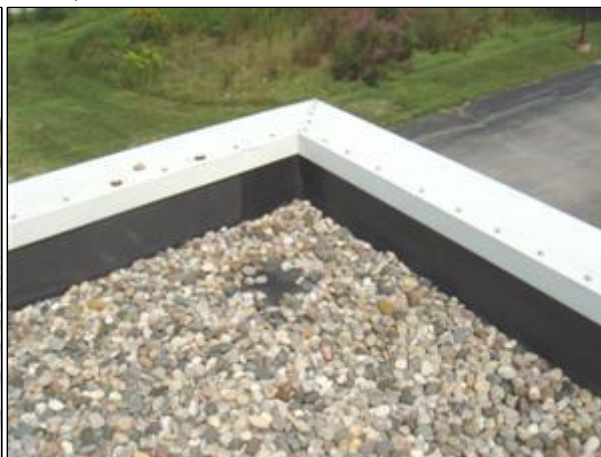
The roof coverings are in very good condition.(Picture 1)(Picture 2)

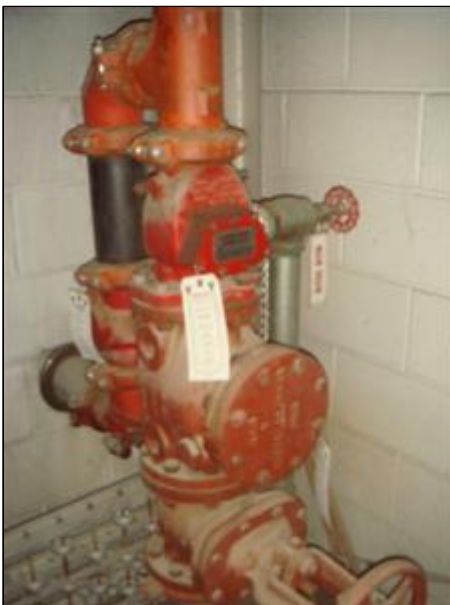
4.2 Picture 1

The Fire suppression system is being tested as required by the State of Michigan.(Picture 1)

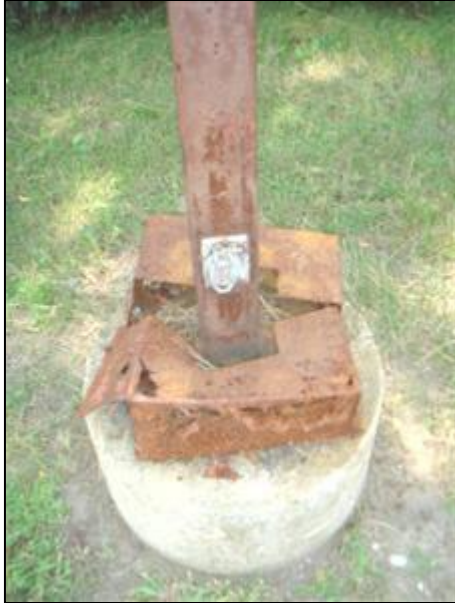
5.3 Picture 1

The parking lot light pole base cover on the south side is rusted and both poles are rusted and need to be painted. (Picture 1)

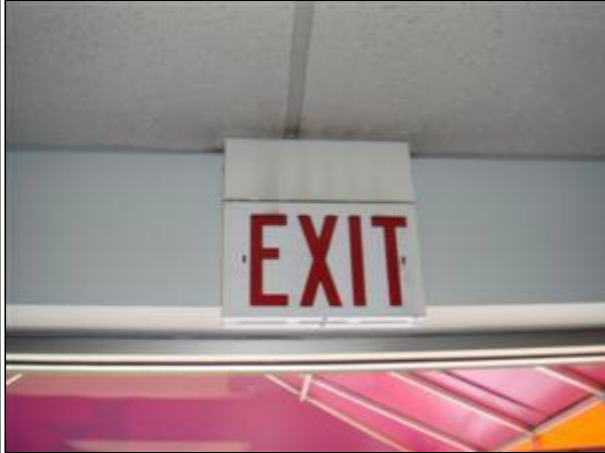
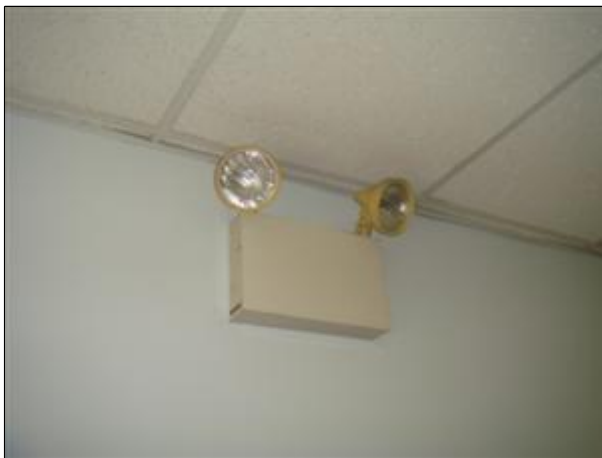
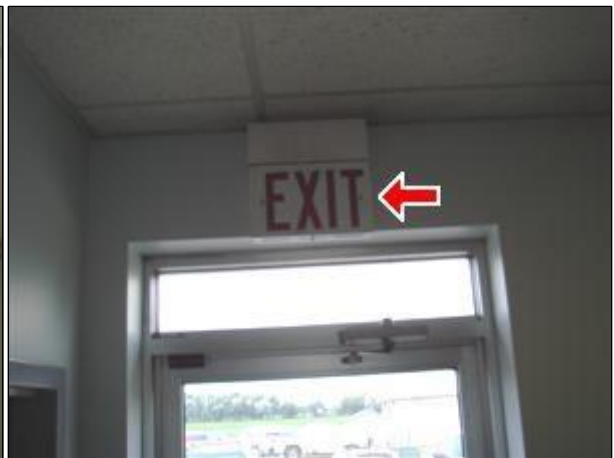
The EXIT and emergency lights in the customer area and the mens bathroom and over the employees entry door are not working. (Picture 2)(Picture 3)(Picture 4)

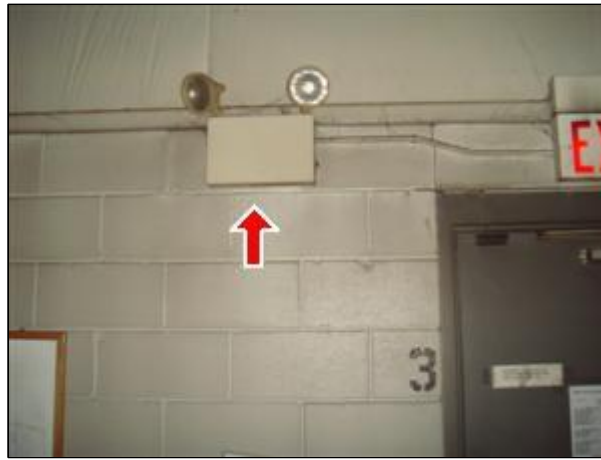
5.3 Picture 5

Two of the emergency lights in the shipping area are not working. (Picture 5)

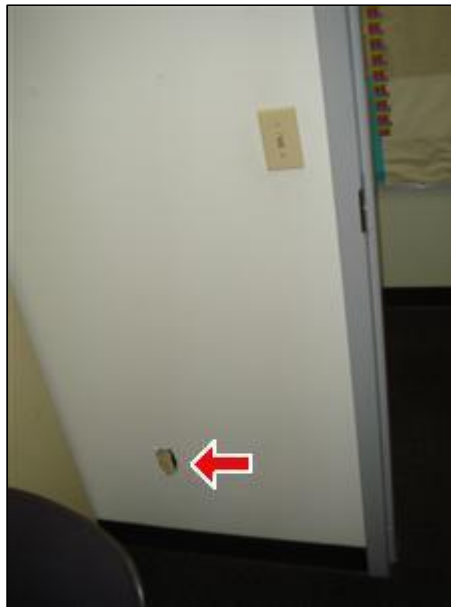
5.4 Picture 1

The plug cover is missing in employees brake room.(Picture 1)

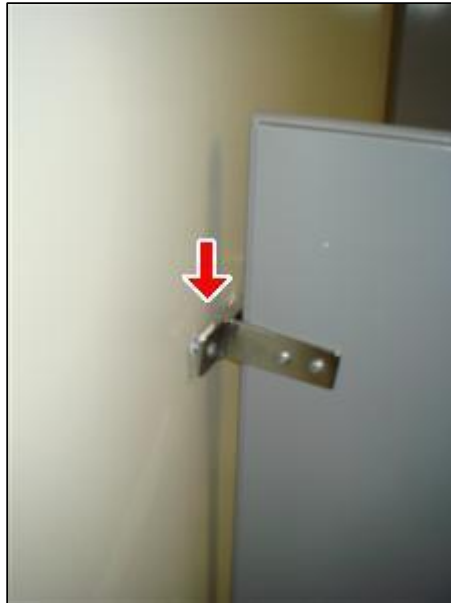
8.1 Picture 1

The urinal screen in the mens bathroom is pulling out of the wall.(Picture 1)

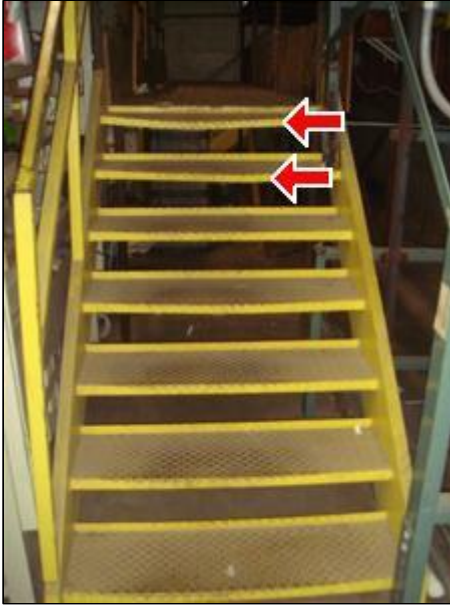
8.3 Picture 1

The top two steps on the truck loading conveyor are bent.(Picture 1)

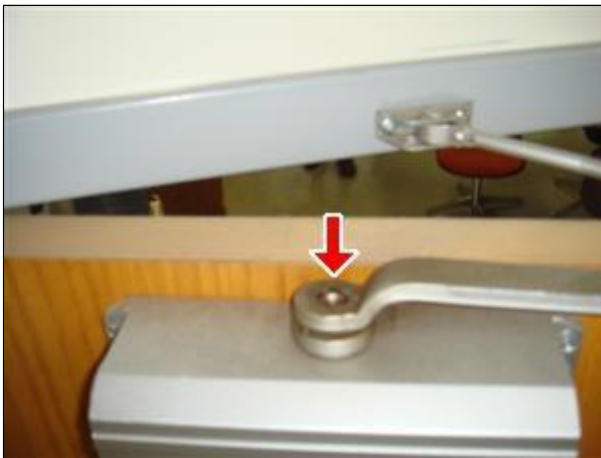
8.5 Picture 1

The top screw in the closer arm (Picture 1) in the mens bathroom is missing causing the arm to hit the top of the door every time the door is open.

The top screw in the closer arm(Picture 1) in the mens bathroom is missing causing the arm to hit the top of the door every time the door is open.

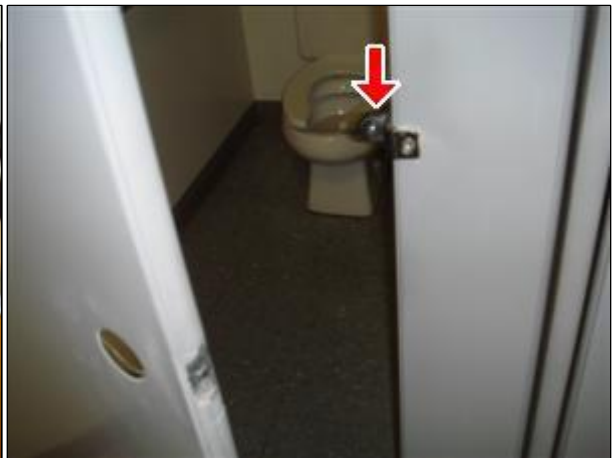
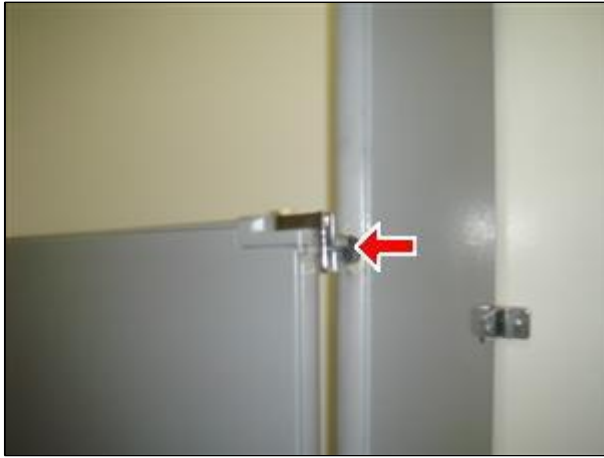
Both of the women's toilet room doors are in the need of repair. (Picture 2) (Picture 3)

Both of the women's toilet room doors are in the need of repair.(Picture 2)(Picture 3)
